# Impact of Erosive Media on Hybrid Ceramic Occlusal Veneers

**Objectives:** This in-vitro study investigated the effect of hybrid ceramic material type and erosive media on the fracture resistance and failure mode of occlusal veneer restorations.

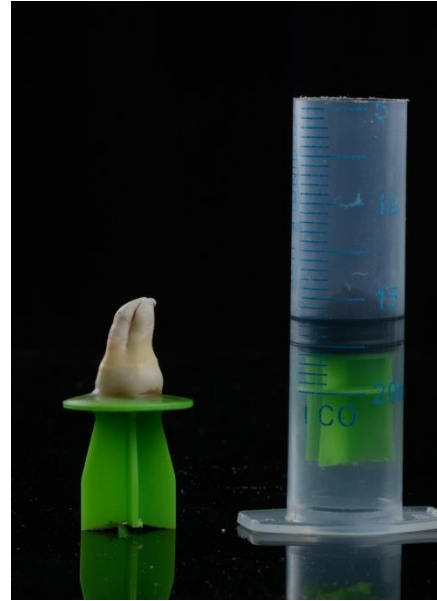
**Figure 1:** Extracted tooth mounted in a custom jig for standardized positioning before embedding in epoxy resin mold.

Each tooth was embedded vertically in epoxy resin (Kemapoxy 150, Chemicals for Modern Building International, CMB, Giza, Egypt) within a cylindrical plastic ring (2 mm height, 2.5 mm diameter). A custom centralizing device ensured the long axis of the tooth was aligned parallel to the

resin block's axis (Figure 1). The CEJ was positioned 2 mm above the resin surface and teeth were held in place until the resin fully polymerized.

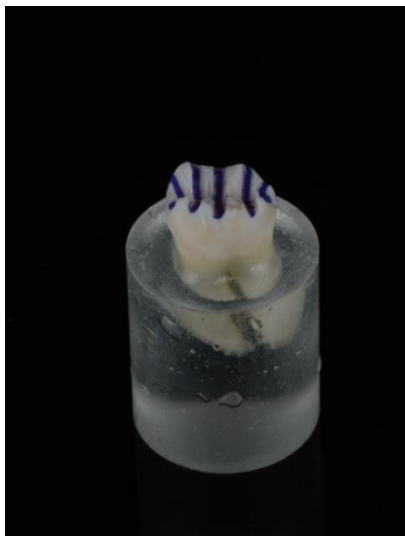
**Figure 2:** Tooth marked for occlusal veneer preparation with 1 mm depth orientation holes at cusp tips and fossae using a tapered diamond bur.

Occlusal preparations were standardized and performed using a surveyor milling machine (Marathon 103, Marathon, China) with a low-speed hand piece (Strong Traus AT-II, Saeshin Precision Co., Korea) mounted at 150° angulations. Depth orientation holes of 1 mm were made at cusp tips and fossae using tapered diamond burs (TR-24, MANI Inc., Japan) and confirmed with a periodontal probe (Figure 2). Enamel was reduced uniformly by 1 mm following occlusal anatomy, verified against the putty indices. An additional 1 mm depth reduction into dentin was then performed. Preparations were confined to the occlusal surface with a straight finish line and no axial reduction, per manufacturer guidelines (Figure 3).<sup>[23]</sup>

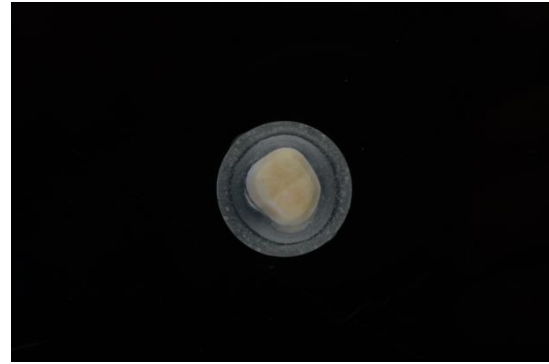
**Figure 3:** Occlusal view of occlusal veneer preparation design.

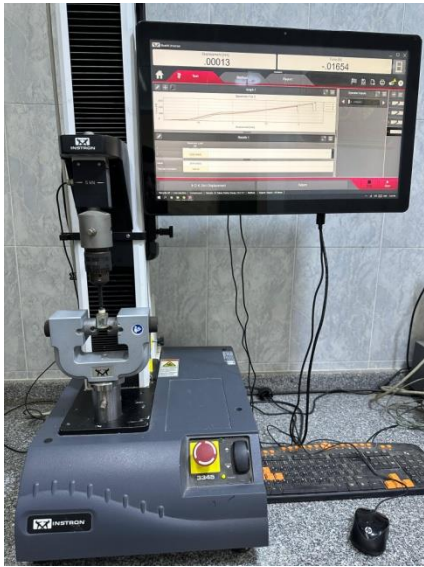
**Figure 4:** Specimen fixed in Universal testing machine for fracture load testing.

All specimens were tested under identical conditions to ensure standardization across groups. Each specimen was tested individually using a universal testing machine (Instron Model 3345, Instron Corp., USA) equipped with a 5 kN load cell and operated via BlueHill 3 software. Specimens were secured with mounting screws, and a 0.6 mm thick tin foil was placed between the occlusal surface and a 6 mm diameter hemispherical steel loading rod to ensure uniform force distribution. A compressive load was applied vertically along the long axis at a crosshead speed of 2.0 mm/min until fracture occurred (Figure

4). The maximum load at failure was recorded in Newtons (N).

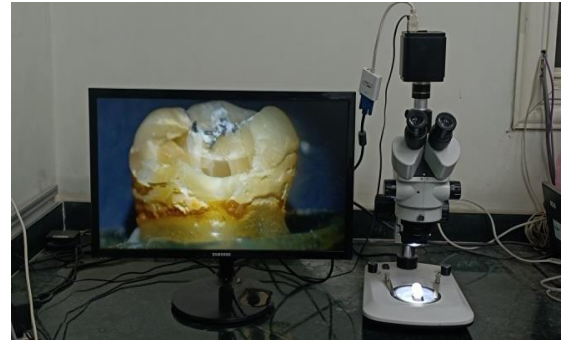
**Figure 5:** Fractured specimen after static load testing, showing a Class IV longitudinal fracture involving both the restoration and tooth under a stereomicroscope.

After fracture testing, all specimens were retrieved and examined under a stereomicroscope at  $\times 20$  magnification (Figure 5). Failure modes were classified into four categories: Class I, extensive crack propagation within the restoration; Class II, complete fracture of the restoration only; Class III, adhesive failure at the restoration-tooth interface; and Class IV, longitudinal fracture involving both restoration and tooth (Figure 6).<sup>[23]</sup>

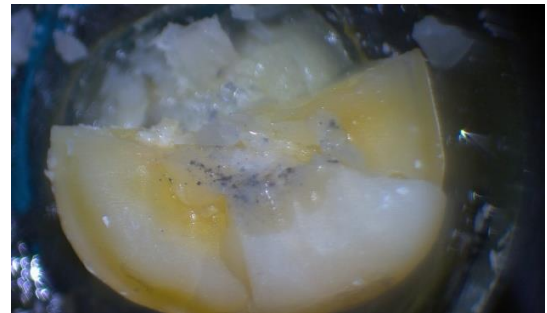
**Figure 6:** Occlusal view of a specimen from the SA subgroup showing a Class IV fracture.
